1965-1969 Chevrolet Corvair valve adjustment

This guide will go through the process of adjusting the valves with the engine running.

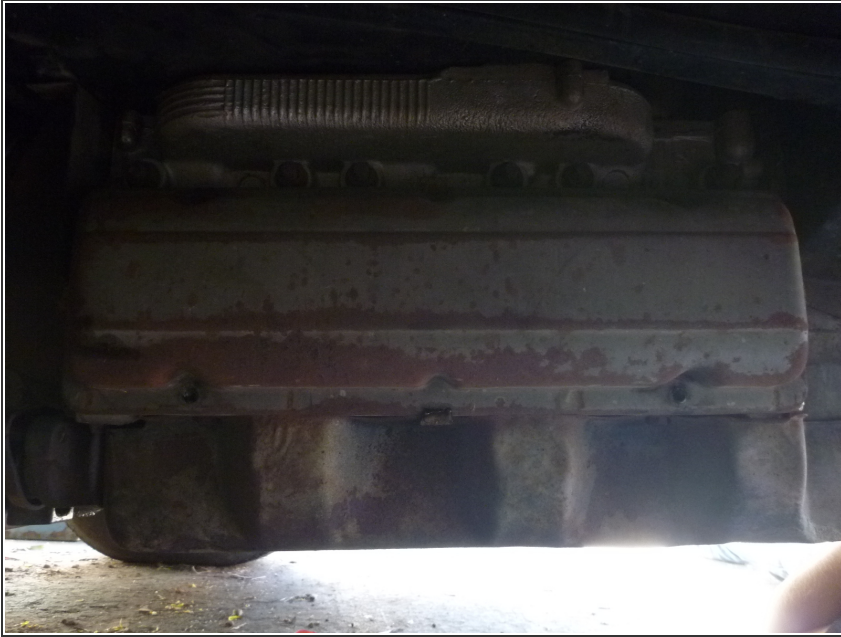
Step 1 — 1965-1969 Chevrolet Corvair valve adjustment

- Adjusting the valves first requires removing the valve cover. There are two valve covers, one on each side of the car. In this guide we'll be adjusting the valves on the drivers side, which does not have the exhaust in the way.
- Look under the back of the car, and on the side of the engine you will see the valve cover.

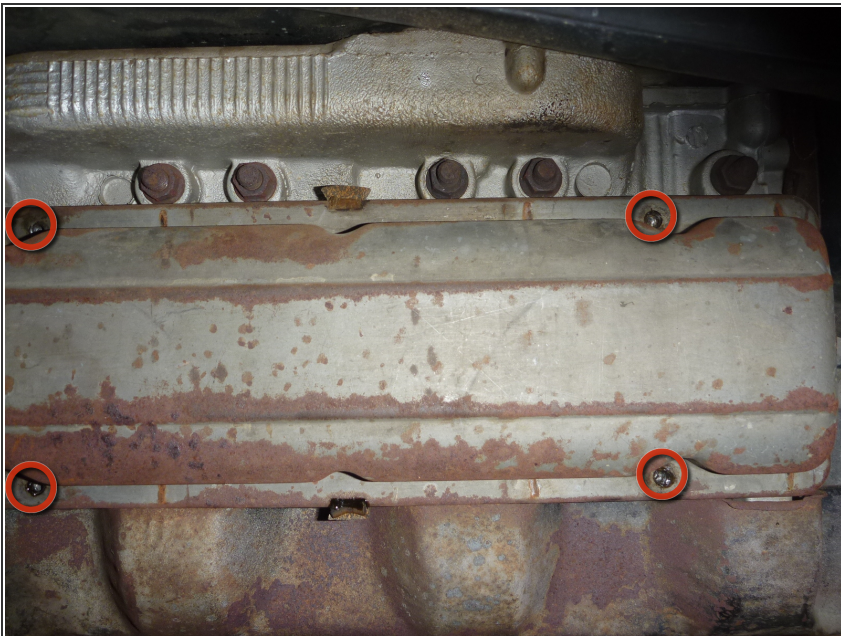
Step 2

- In order to remove the valve cover, locate the 4 bolts which hold it in place and remove them using a 7/16" socket or wrench.
- ⚠ Remove them carefully to avoid stripping the holes.

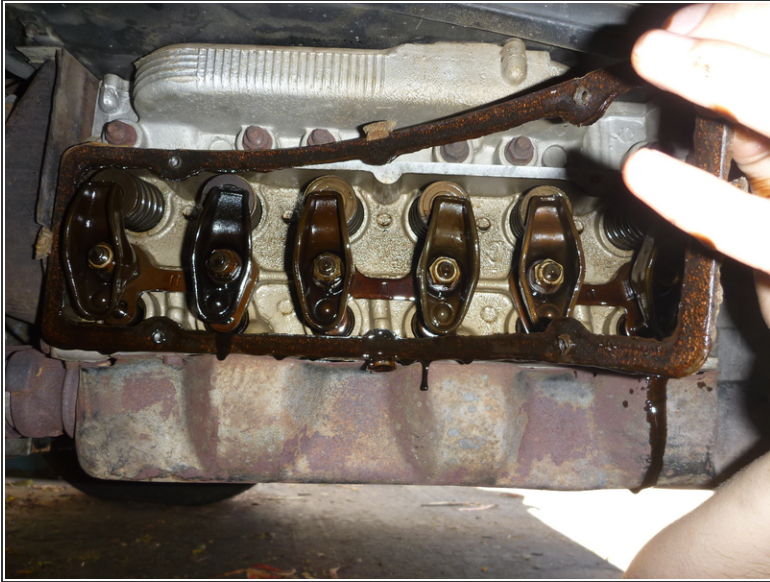
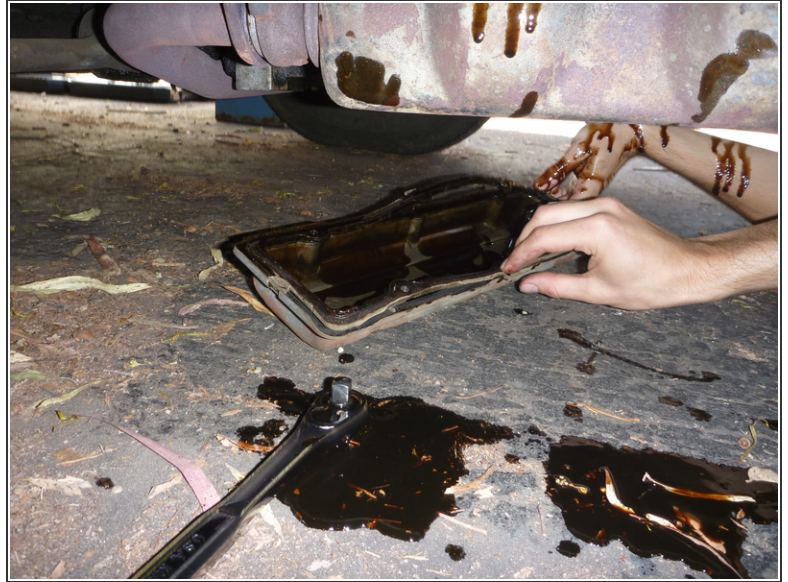
Step 3

- Next, remove the valve cover and the gasket by pulling out gently.
- Put a piece of cardboard below to capture the oil which will spill out.

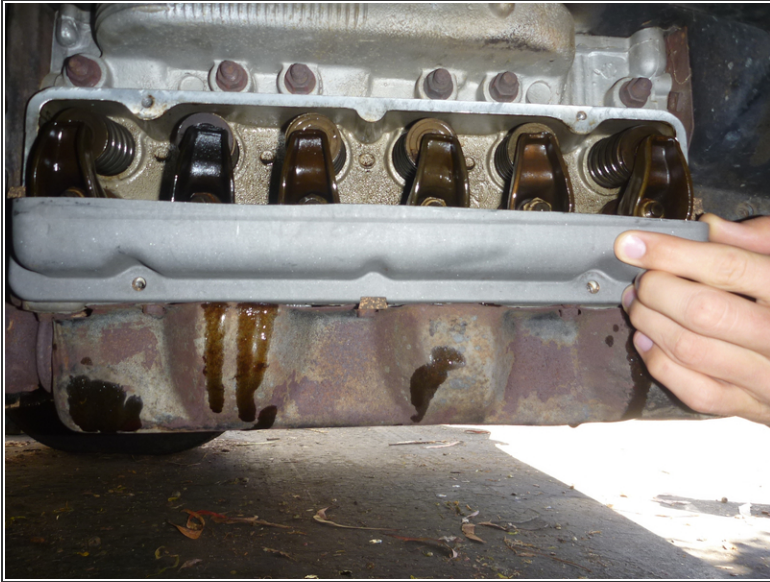
Step 4

- Now you must attach the 1/3 Valve Cover, which is essentially 1/3 of a valve cover that keeps the oil in while exposing the valves so you can adjust them when the engine is running.
- Place the valve cover on the lower side of the valves and line up the bolt holes. Verify the gasket is in place and use the bolts you previously removed to attach the adjustment cover.

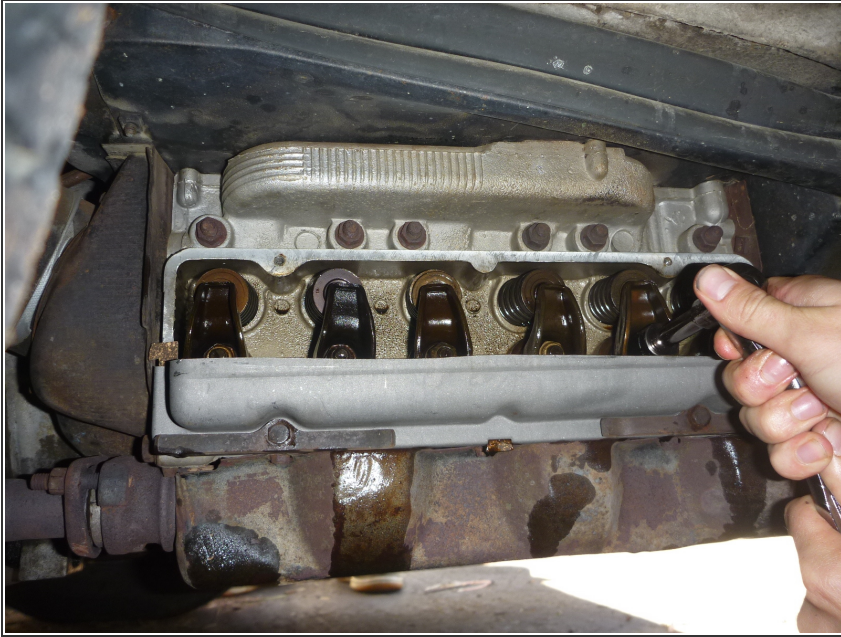
Step 5

- Finally, turn on the engine and you are ready to adjust.
- Start on the left side and adjust each one at a time using a 5/16" socket.
- Loosen the bolt on the lifter till you hear that lifter start ticking. The ticking noise should be quite apparent.
- Then slowly tighten it till it stops ticking. And then tighten in one half turn. Now you can move on to the next valve.

To reassemble, simply follow steps 1-4 in reverse order. Make sure to adjust the valves on the other side of your engine using the same procedure.
